UNITED STATES DISTRICT COURT EASTERN DISTRICT OF MISSOURI EASTERN DIVISION

vs. : Case No. 4:19-cv-01696

SERVE ALL HOSPITALITY LLC, a Missouri limited liability company

COMPLAINT

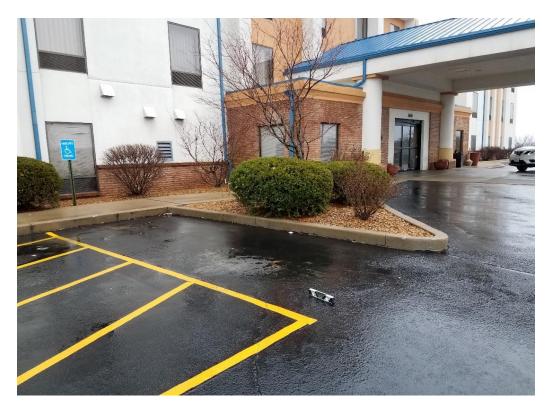
a. (i) In the parking lot, the front (closer to the building) and back sections of the parking space for disabled patrons shown in the photograph below have a running slope steeper than 1:48 (2%). (ii) The front and back sections of this parking space has a running slope steeper than the maximum allowed slope of 1:48 (2%), in violation of Federal Law 2010, ADAAG § 502.4. (iii) The Plaintiff encountered these steep slopes in this parking space, and it made his wheelchair unstable. (iv) The action required to reduce the slope of this parking space is easily accomplishable and able to be carried out without much difficulty or expense.

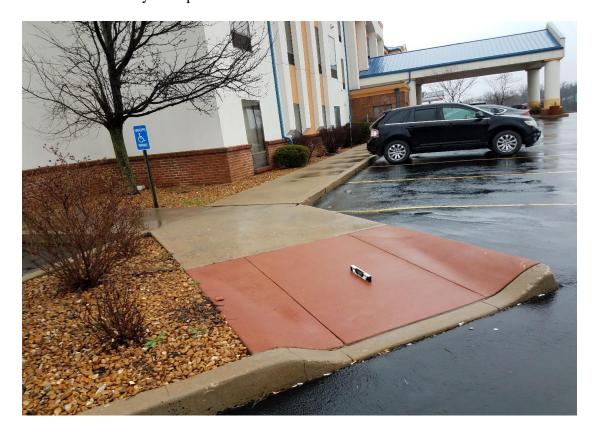
- e. (i) The running slope of the access ramp shown in the photograph below is steeper

than 1:12 (8%). (ii) The running slope of this access ramp is steeper than the maximum allowed slope of 1:12 (8%), in violation of Federal Law 2010, ADAAG § 405.2. (iii) The Plaintiff encountered this access ramp while moving in his wheelchair, and due to its steep slope, he required assistance to ascend and to descend this ramp. (iv) The action required to reduce the slope of this access ramp is easily accomplishable and able to be carried out without much difficulty or expense.

g. (i) The cross slopes of the curb ramp sides or flares of the access ramp shown in the photograph below subparagraph (e) above is steeper than 1:10 (10%). (ii) These curb ramp sides or flares are as steep as about 1:2.3 (43.3%) and steeper than the maximum allowed slope of 1:10 (10%), in violation of Federal Law 2010, ADAAG § 406.3. (iii) The Plaintiff observed these curb ramp sides, and he had to avoid them so that his wheelchair would not overturn. (iv) The action required to reduce the slope of these curb ramp sides is easily accomplishable and able to be carried out without much difficulty or expense.

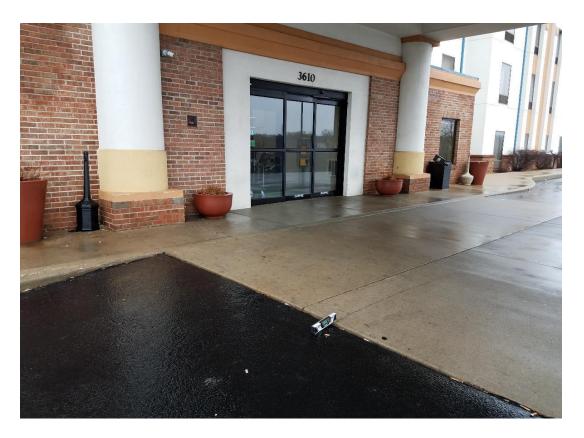
h. (i) The change in level of the walking surface on the accessible route to the entrance of the Quality Inn & Suites is greater than 0.25 inches at the intersection of the black top to the cement shown in the photograph below. (ii) This change in level of this walking surface is about 1 inch and greater than the maximum allowed change in level of 0.25 inches, in violation of Federal Law 2010, ADAAG § 502.4 and 303.2. (iii) While moving in his wheelchair, the Plaintiff encountered this change of level, and he required assistance to move over it in his wheelchair. (iv) The action required to reduce this change of level is easily accomplishable and able to be carried out without much difficulty or expense.

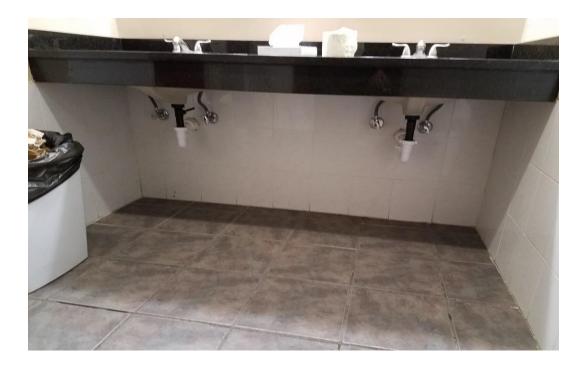
1. (i) The lavatory drain and supply pipes under the sink in the men's restroom are not insulated. (ii) As shown in the photograph below, these drain and supply pipes under this sink are not insulated, in violation of Federal Law 2010, ADAAG §§ 606.3 and 606.5. (iii) The Plaintiff used this sink and he risked skin burns and injury to his legs due to the lack of insulation on these drain and supply pipes under the sink. (iv) The action required to insulate these pipes under this sink is easily accomplishable and able to be carried out without much difficulty or expense.
